SOLVING ROOF AND BALCONY LEAKS IS NOT JUST ABOUT WATERPROOFING

BY PAUL EVANS, MANAGING DIRECTOR OF FINDLAY & EVANS WATERPROOFING, PRESIDENT OF THE AUSTRALIAN INSTITUTE OF WATERPROOFING (AIW), AND REGISTERED BUILDING PRACTITIONER

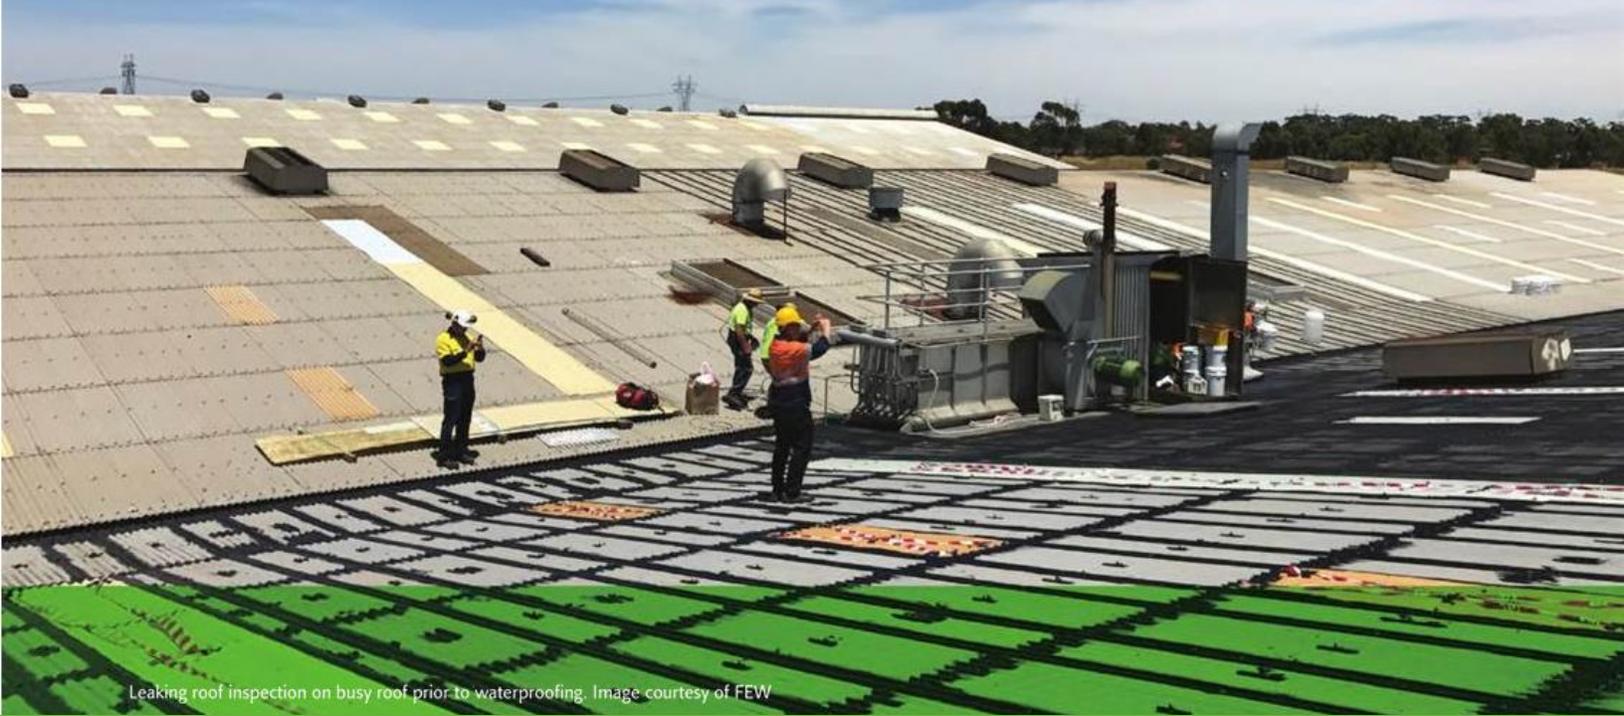
Leaking roof inspection on busy roof prior to waterproofing. Image courtesy of FEW

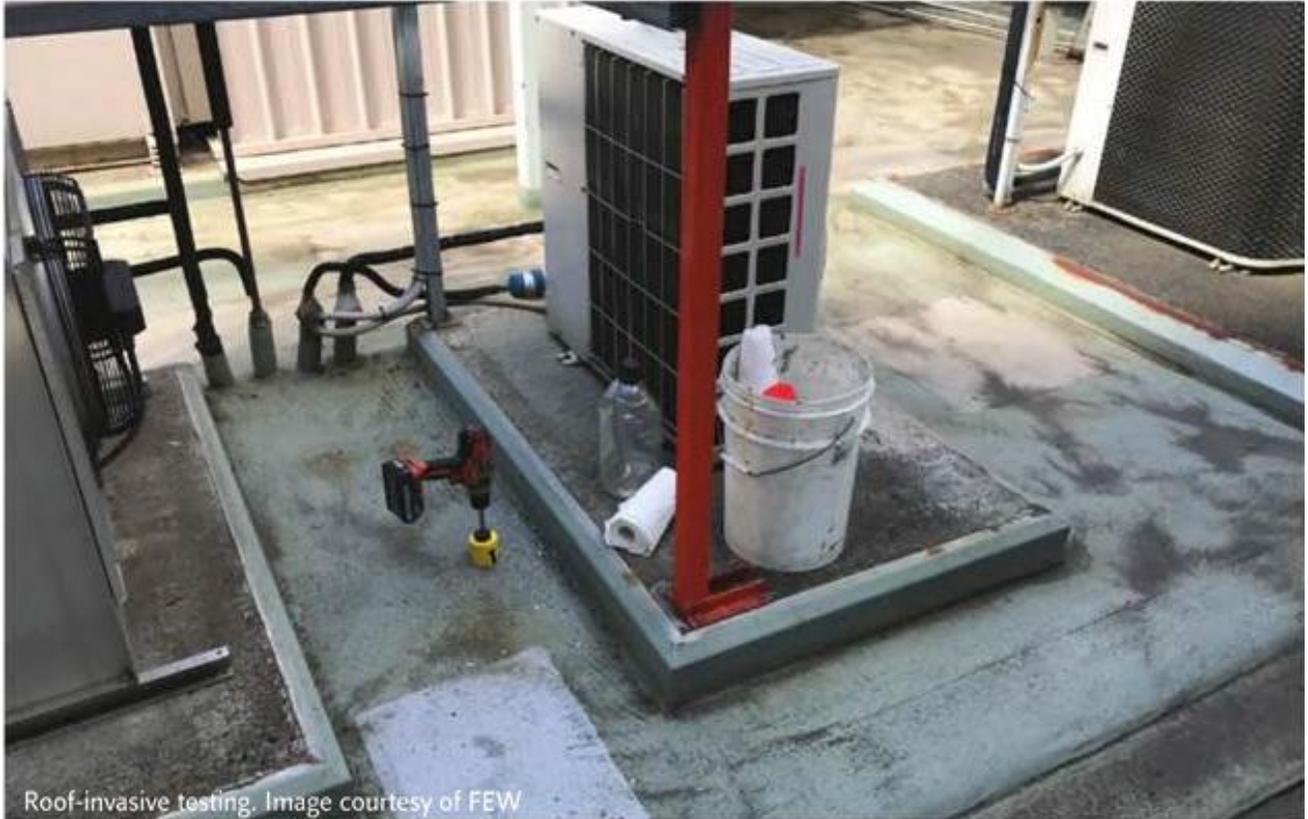
Roof-invasive testing. Image courtesy of FEW

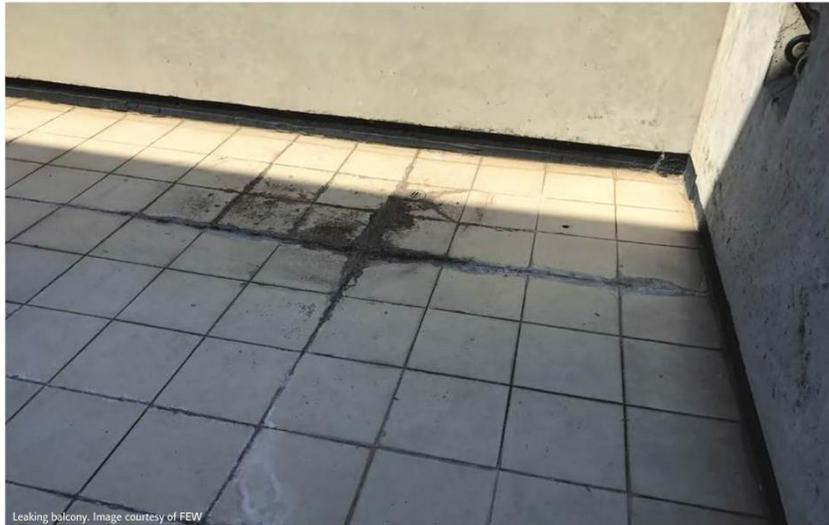
Leaking balcony. Image courtesy of FEW
